**TENNESSEE DEPARTMENT OF ENVIRONMENT AND CONSERVATION
ENVIRONMENTAL FIELD OFFICE**

Re: Compliance Evaluation Inspection (CEI)

Mueller Company
TMSP Tracking Number: TNR051467
1401 Mueller Avenue
Hamilton County, Tennessee

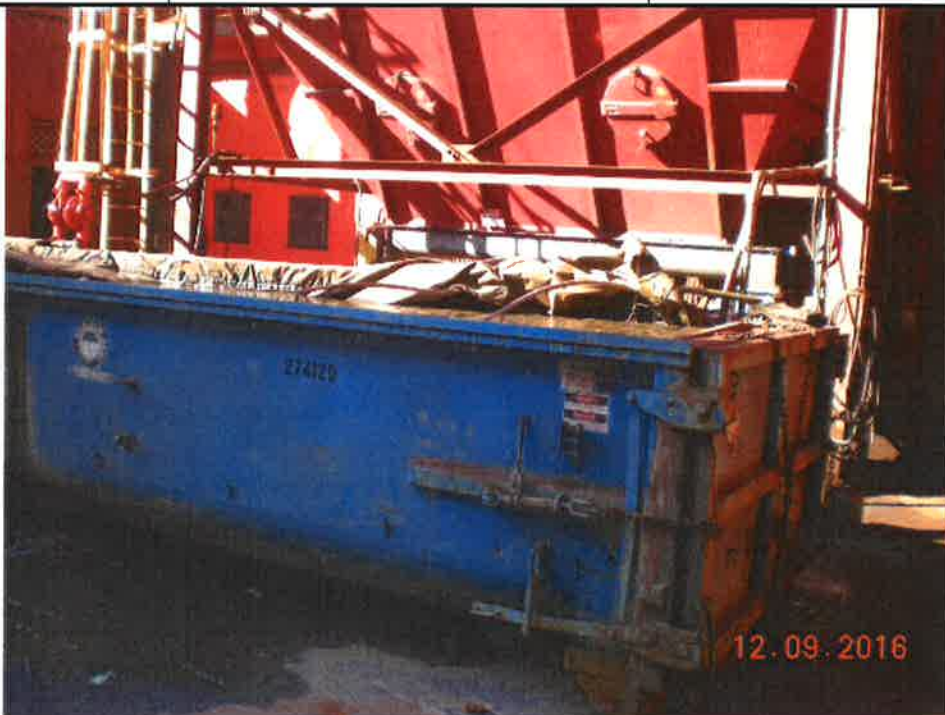
A corridor between two buildings begins at the south door of the foundry sand storage building. Mr. Bascom observed a large blue roll-off bin covered by a heavy tarpaulin staged in this corridor (Figures 1, 2 and 3). Personnel stated that the "blue box" (roll-off bin) contains quench/make-up water. Occasionally this bin may overflow and go into the storm drain located here. Mr. Bascom commented that the "blue box" has been the source of several complaints in recent years. As stated above, all facility storm drains are routed to the retention pond and overflow is not an issue.

Facility Name: <div style="text-align: center;">Mueller Company</div>		Site Location: <div style="text-align: center;">Interior corridor</div>	NPDES Tracking No.: <div style="text-align: center;">TNR051467</div>
Photo No. <div style="text-align: center;">1</div>	Date <div style="text-align: center;">December 9, 2016</div>	Description "Blue box" Blue roll-off bin containing quench water staged in interior corridor.
